# INSIGHT Clinical Guide

How to understand and use  
INSIGHT System data

How to use INSIGHT System to  
improve clinical outcomes

Understanding the prosthetic  
socket fitting with INSIGHT  
System

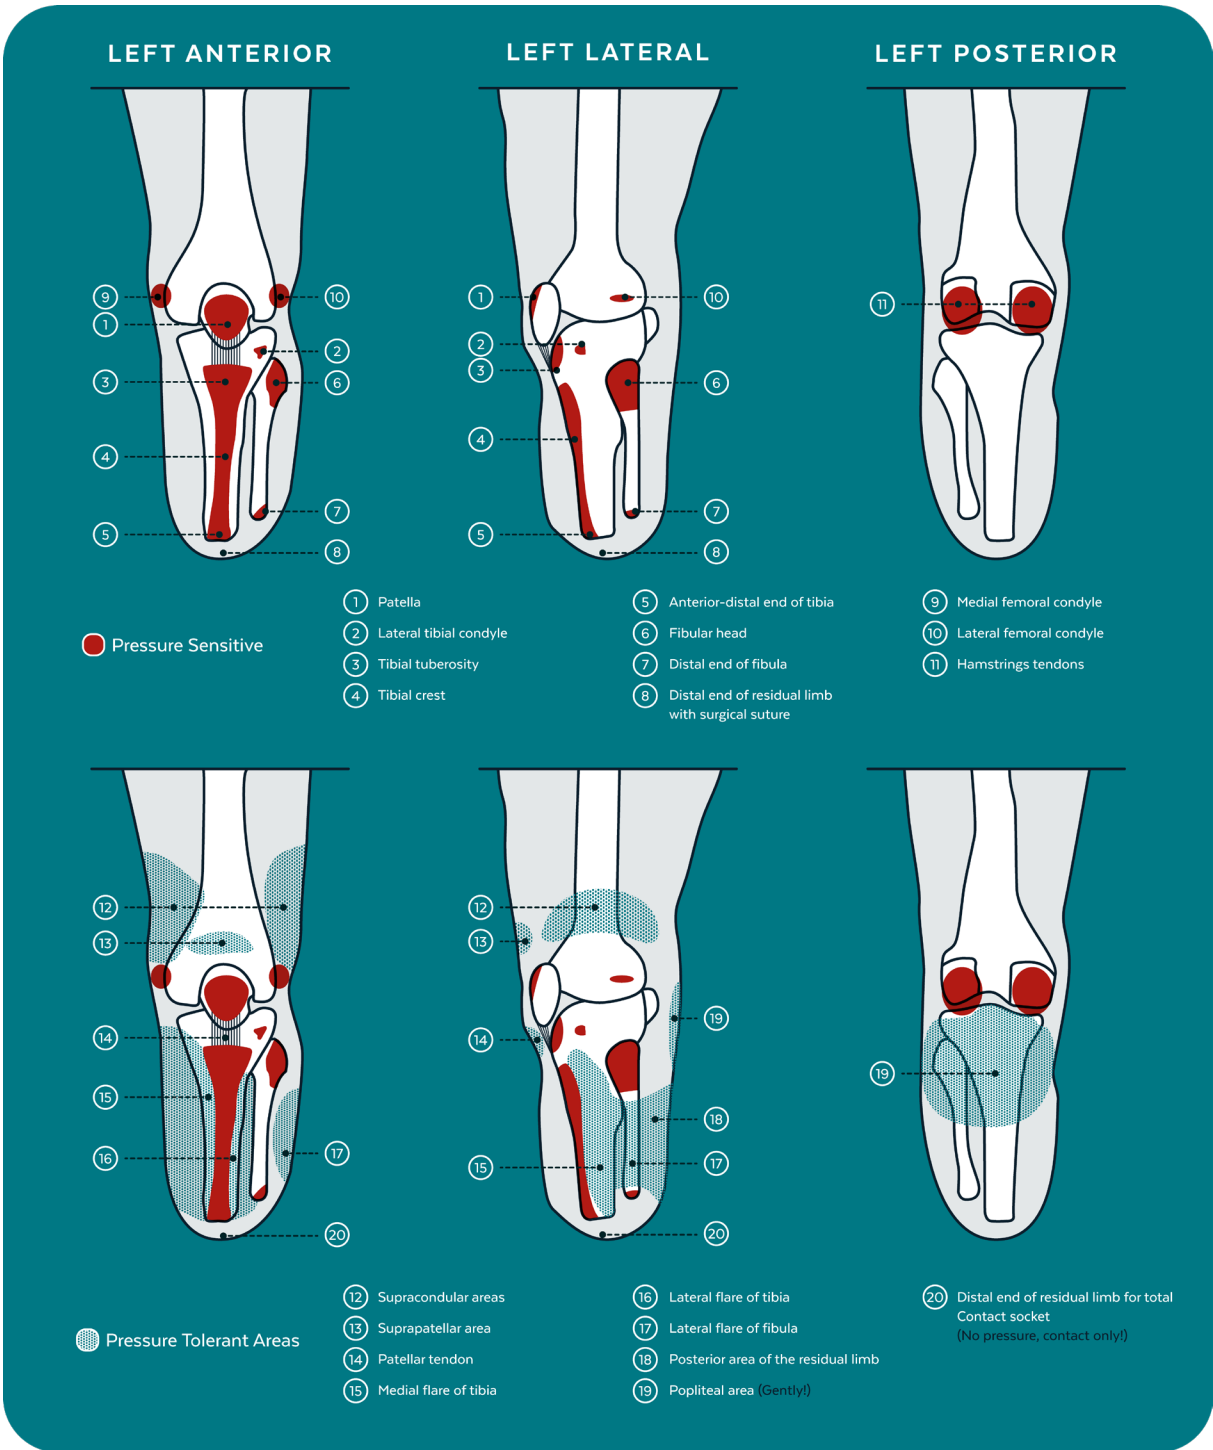
Figure 1: Visuals of pressure tolerant and intolerant areas on a below-knee residual limb.

- If appropriate pressures are being applied in pressure tolerant areas (Figure 1);
- If reliefs built into socket are sufficiently offloading bony and, painful prominences;
- If global volume reduction is appropriate for total surface bearing.

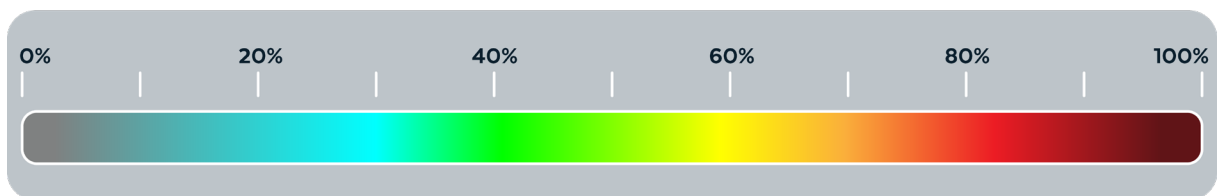
Figure 2: Color scale used in INSIGHT System.

- Blue represents the lowest measured pressure.
- Red represents the highest measured pressure.

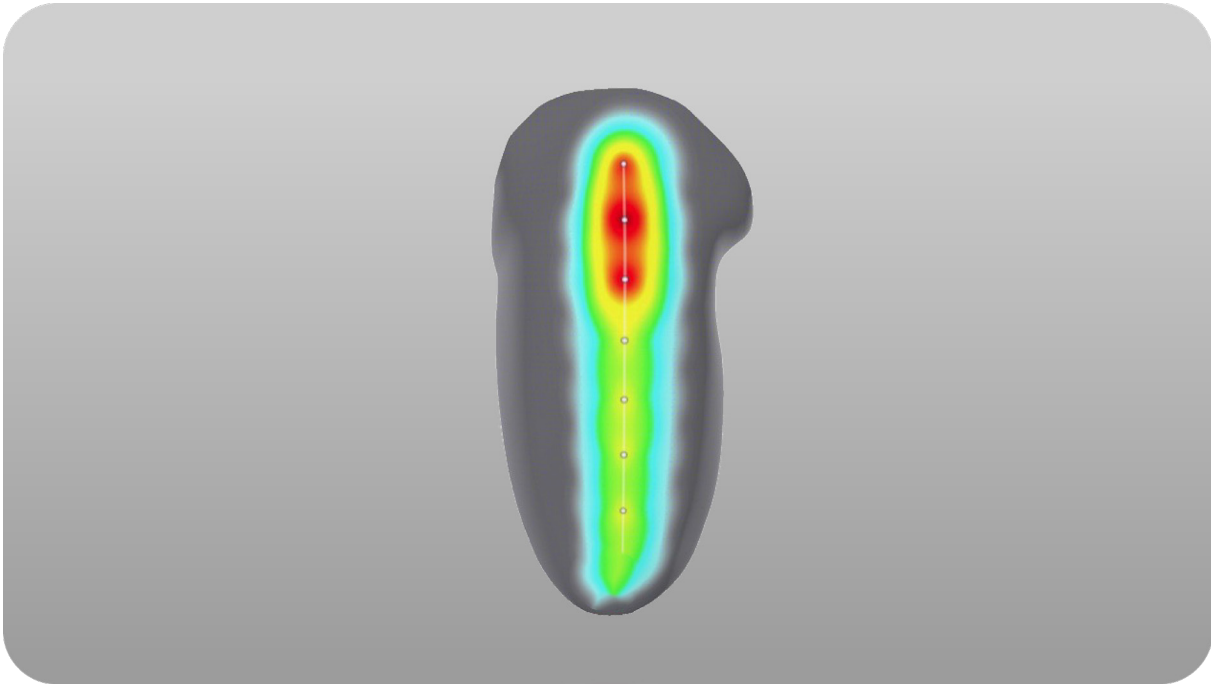
Figure 3: Example of localized pressure on the proximal-medial wall

- Localized red “hotspots” can often cue the practitioner into pressure points (Figure 3).
- While globalized redness spread along the entirety can correlate to a correct total surface bearing.

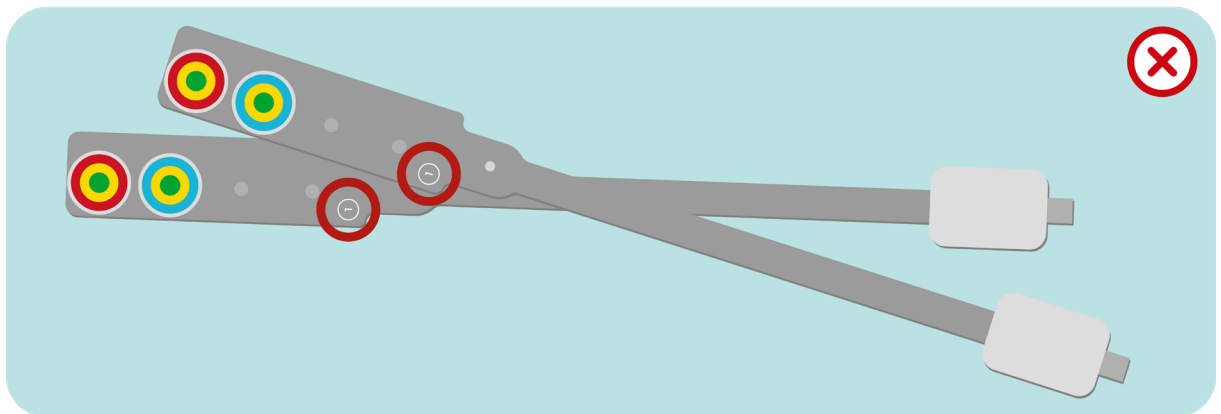
Figure 4: Do not overlap and repeat sensor IDs

- INSIGHT Sensors must not overlap
- You can't use repeated sensor IDs. Sensor ID can be found at the proximal edge of the sensor strip.

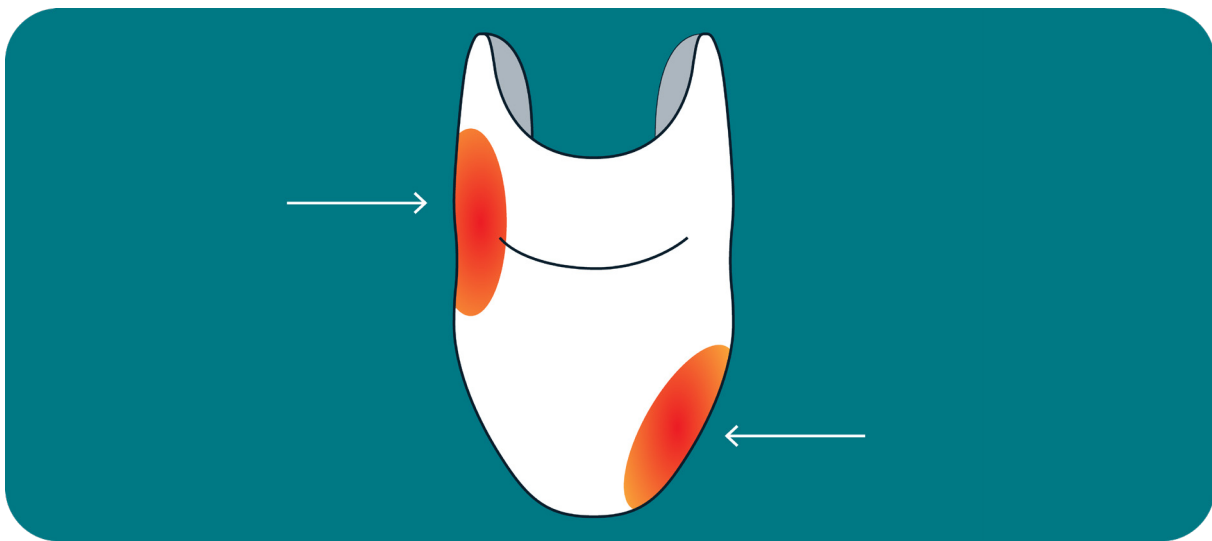
Figure 5: Pressure pair examples.

Pressures in the socket often present in pairs. As such, each pressure will typically present with a similar pressure on the opposite wall. Medial-proximal pressure will correlate with distal-lateral. In Relative mode, it's important to always place at least one strip opposite each other to visualize these opposing pressures accurately (Figure 5).

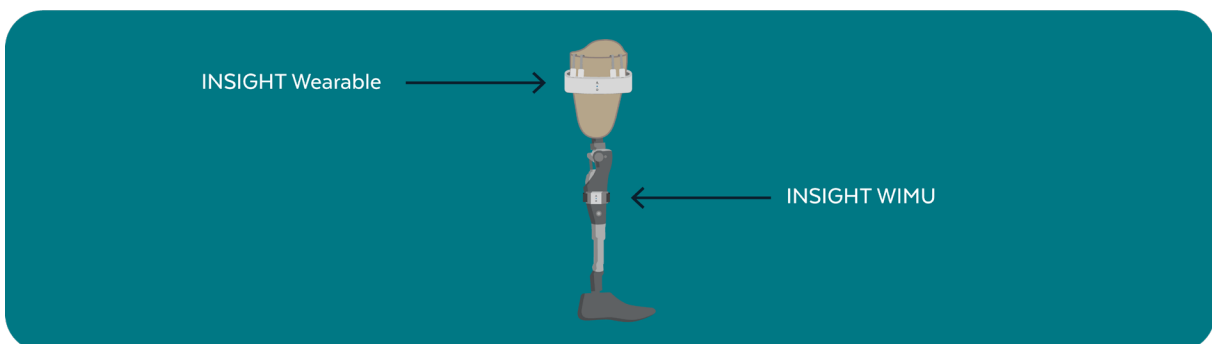
Figure 6: Example of INSIGHT Wearable and INSIGHT WIMU on an AK prosthesis.

- IE – if the amputation is above the knee, INSIGHT Wearable should be placed around the socket and INSIGHT WIMU below the knee (on the pylon).

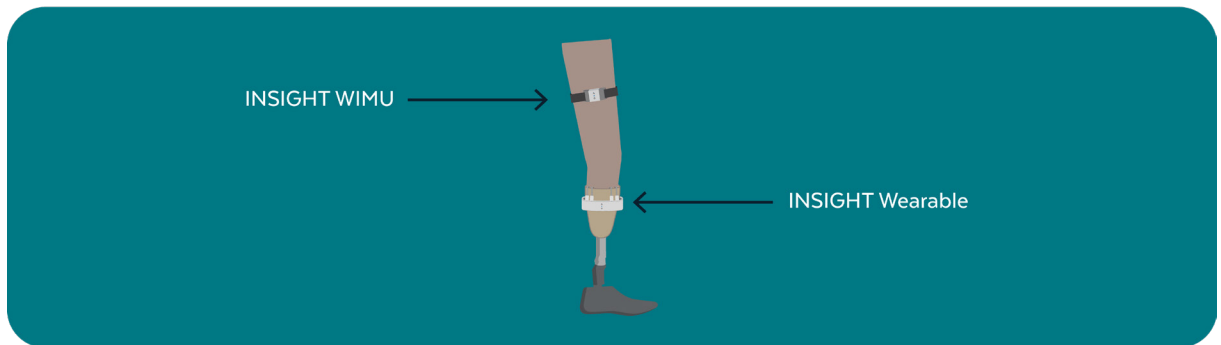
Figure 7: Example of INSIGHT Wearable and INSIGHT WIMU on an BK prosthesis (without knee sleeve).

- If the amputation is below the knee, INSIGHT Wearable should be placed around the socket and INSIGHT WIMU above the knee.

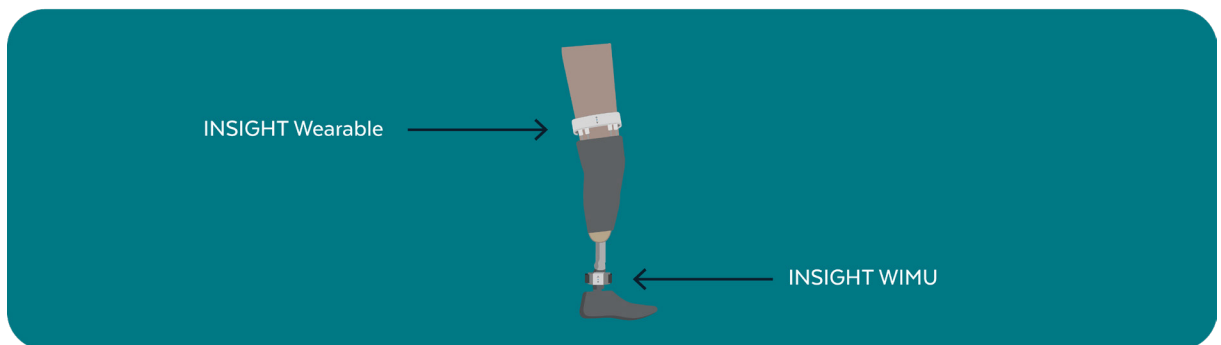
Figure 8: Example of INSIGHT Wearable and WIMU position.

- At times, it may be necessary for the prosthetist to swap the placement of the INSIGHT Wearable and WIMU. (Figure 8). In this will happen when:
  - The patient uses a knee sleeve
  - The prosthetist wants to use more than 4 sensors on a below-knee prosthesis. On this case, he will need to use a Medium Size INSIGHT Wearable.

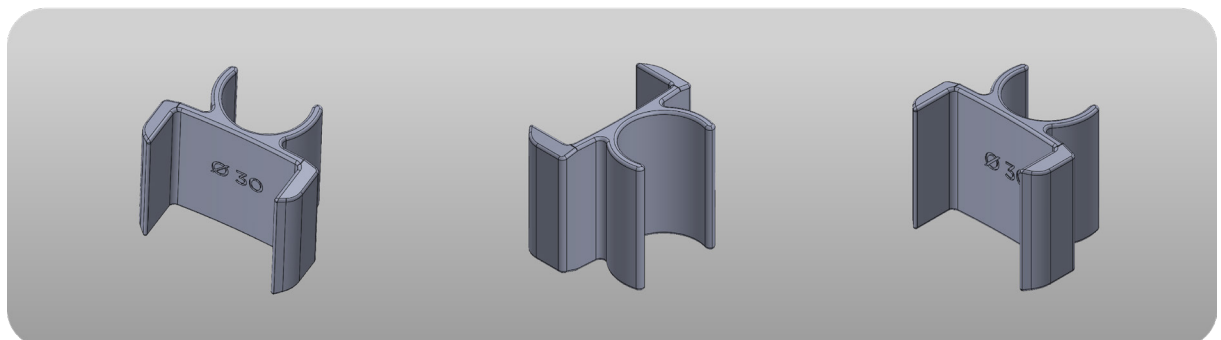
Figure 9: WIMU holder - available for 30mm and 34mm pylon.

It's important to have both components well fixed around the socket/ pylon. If the patient doesn't use a cosmesis and the INSIGHT WIMU needs to be placed on the pylon, Adapttech has created an .STL file for a WIMU holder (Figure 9) that can be printed.

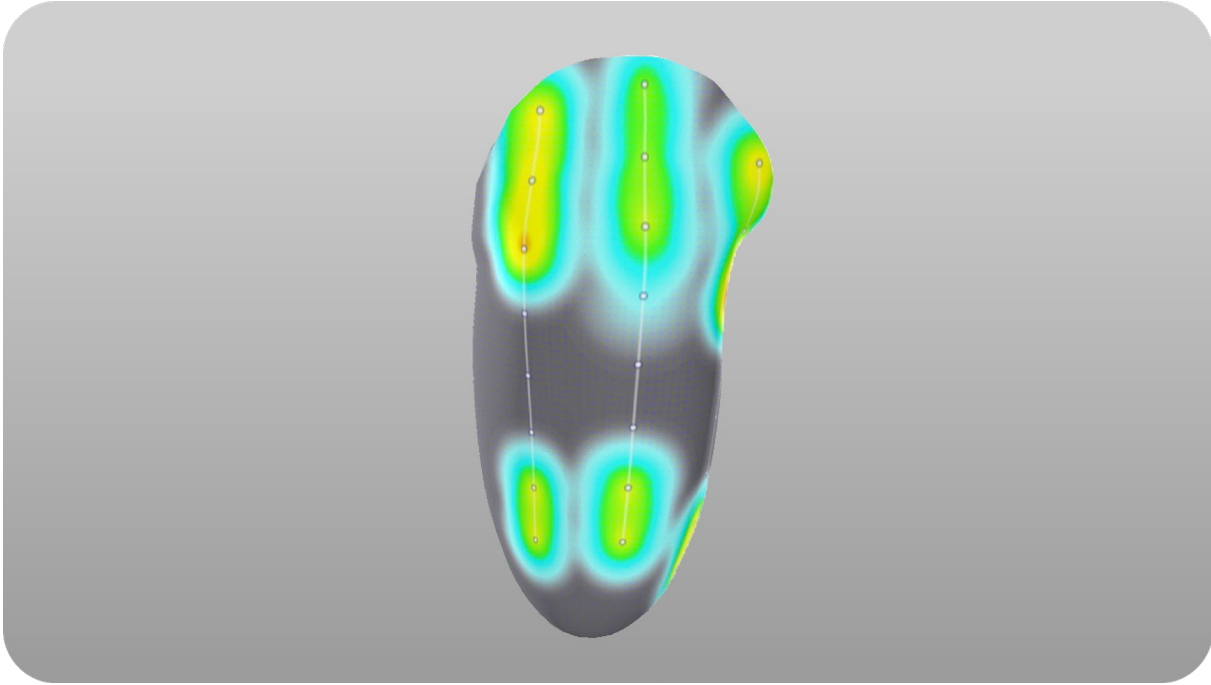
Figure 10: What pressure may look like.

Some Seal-in liners can alter the pressure presentations. Lack of contact around the membrane may cause the visual seen in Figure 10.

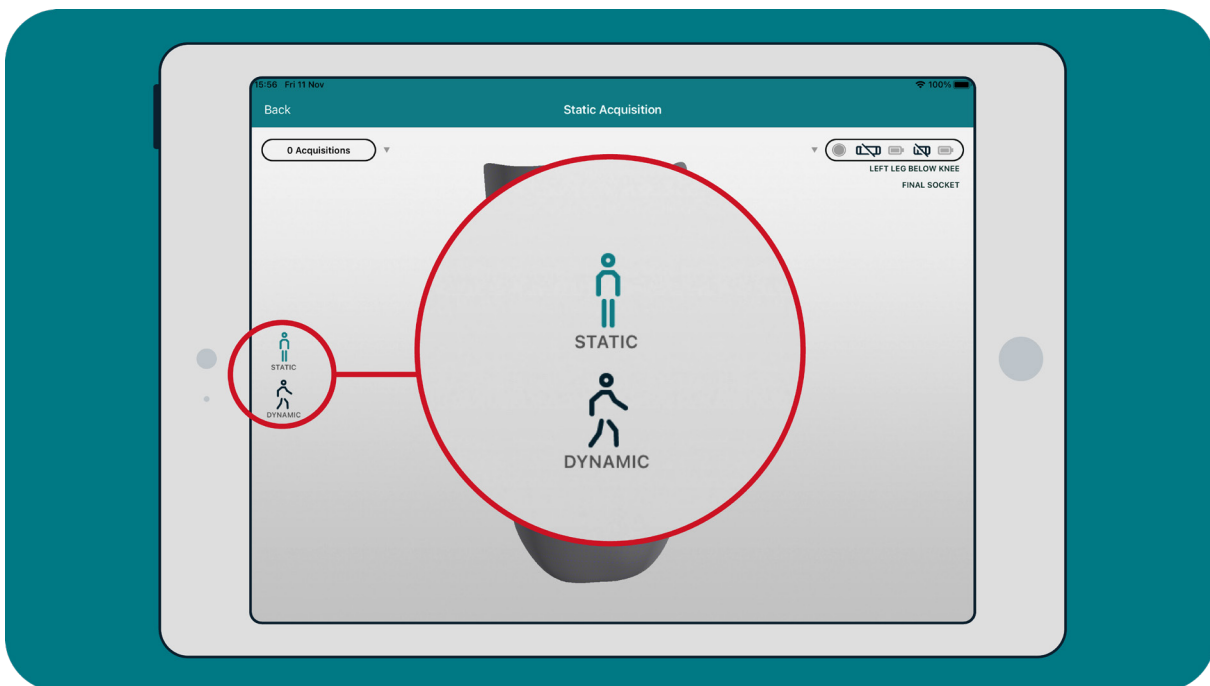
Figure 11: How to select static or dynamic acquisition.

4. Once the volume has been verified, it’s time to proceed to static alignment and static acquisition (Warning: verify if static acquisition is selected. By default, dynamic acquisition is selected on the INSIGHT App. Static acquisition takes at least 30 seconds of the patient standing (Figure 11). After 30 seconds, the app will process the peak pressures recorded and present them in a static 3D model. Alternatively, an unprocessed recording of the entire process can be viewed to pinpoint specific moments during the fitting process.

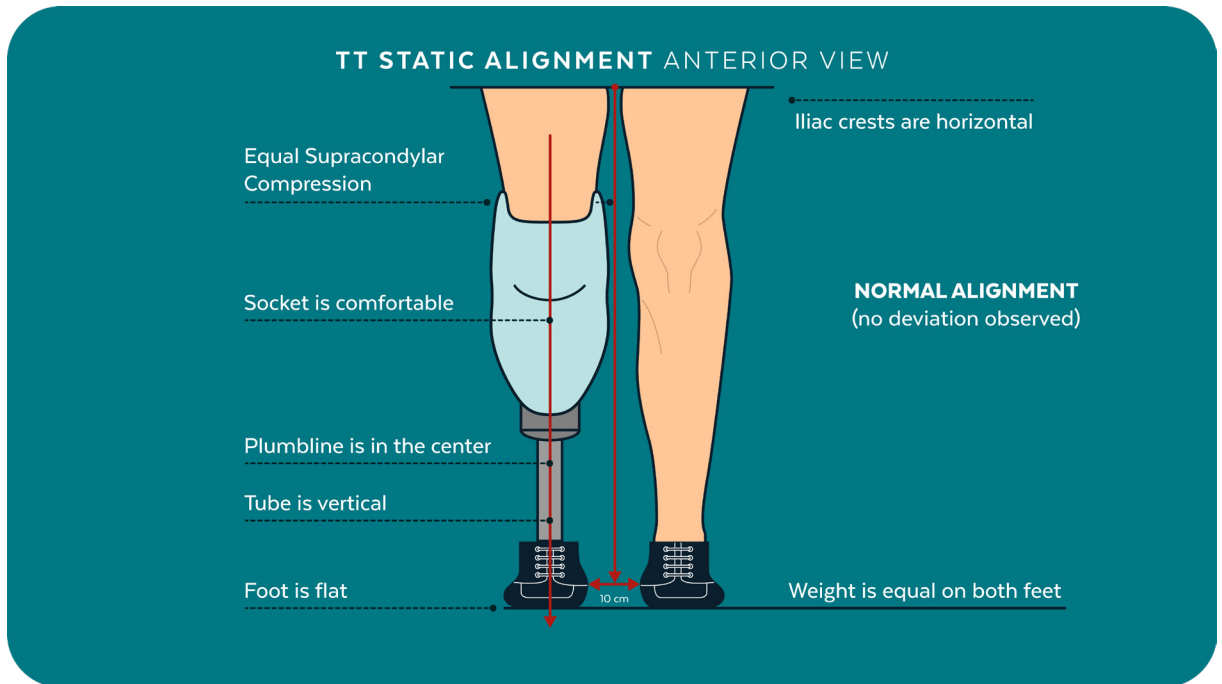
Figure 12: Transtibial socket alignment - anterior view.

- Prosthetists are aware of the impact a socket’s alignment can have on overall comfort for the user. In using the INSIGHT system during initial socket fitting and alignment, the clinician gets a live feed of what the patient may or may not be experiencing.
  - Cue patient to shift weight as you normally would, observe alignment and correlating pressure points – Alter as necessary.
5. Obtain neutral alignment as you normally would. (Figure 12)

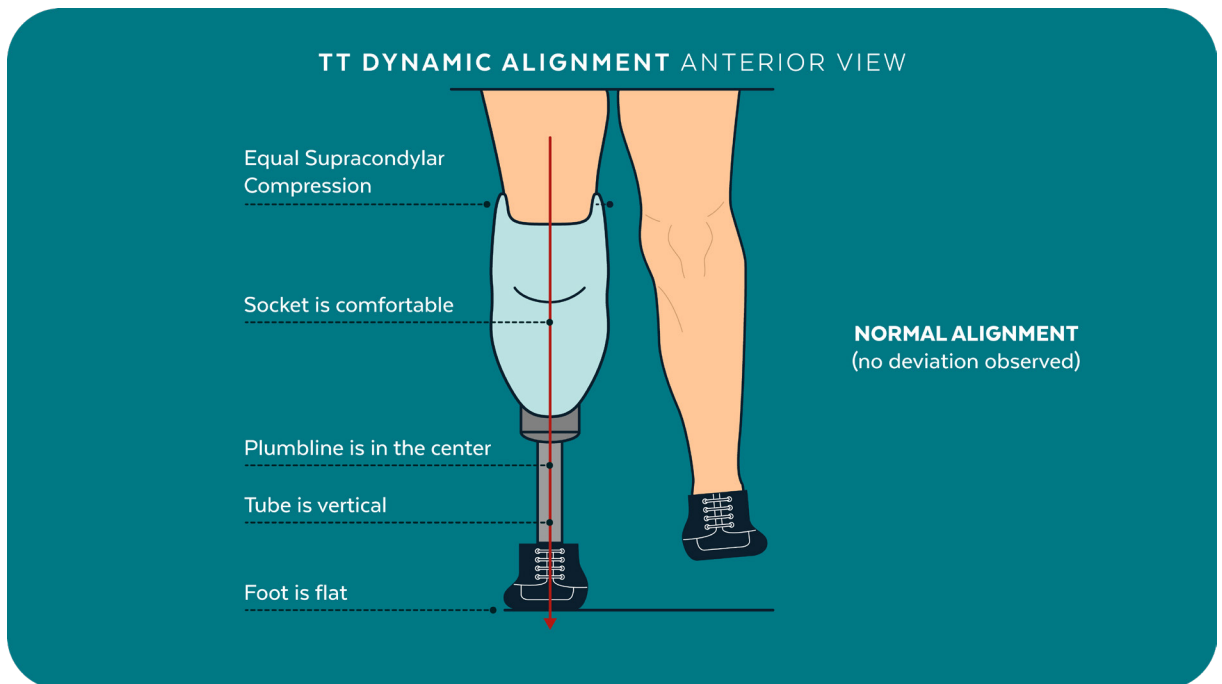
Figure 13: Observation during midstance phase with full weight bearing on prosthesis.

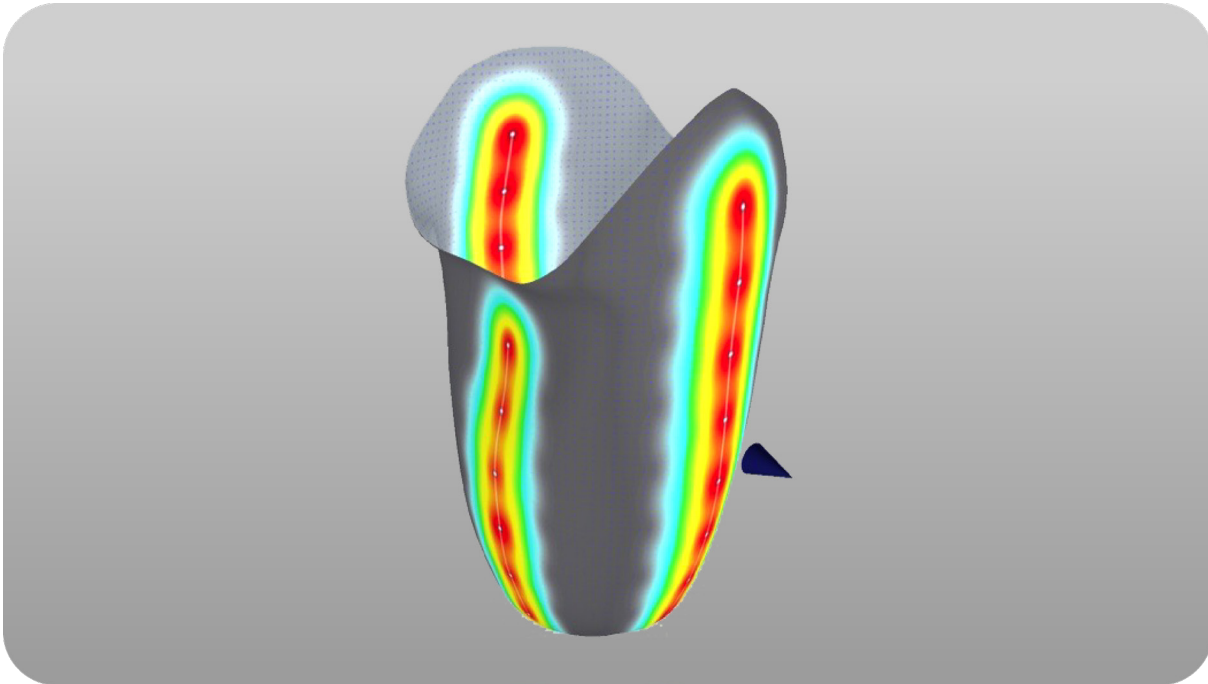
Figure 14: Example of total contact and appropriate distribution of pressure along total surface bearing socket.

2. Press record and wait 5 seconds before asking your patient to walk. This allows the INSIGHT Wearable and INSIGHT WIMU to communicate with each other and calibrate their position.
3. After at least 60 seconds of ambulation, stop the acquisition and check the processed view.
4. Compare to an “appropriate fit” pressure visual (Figure 14).

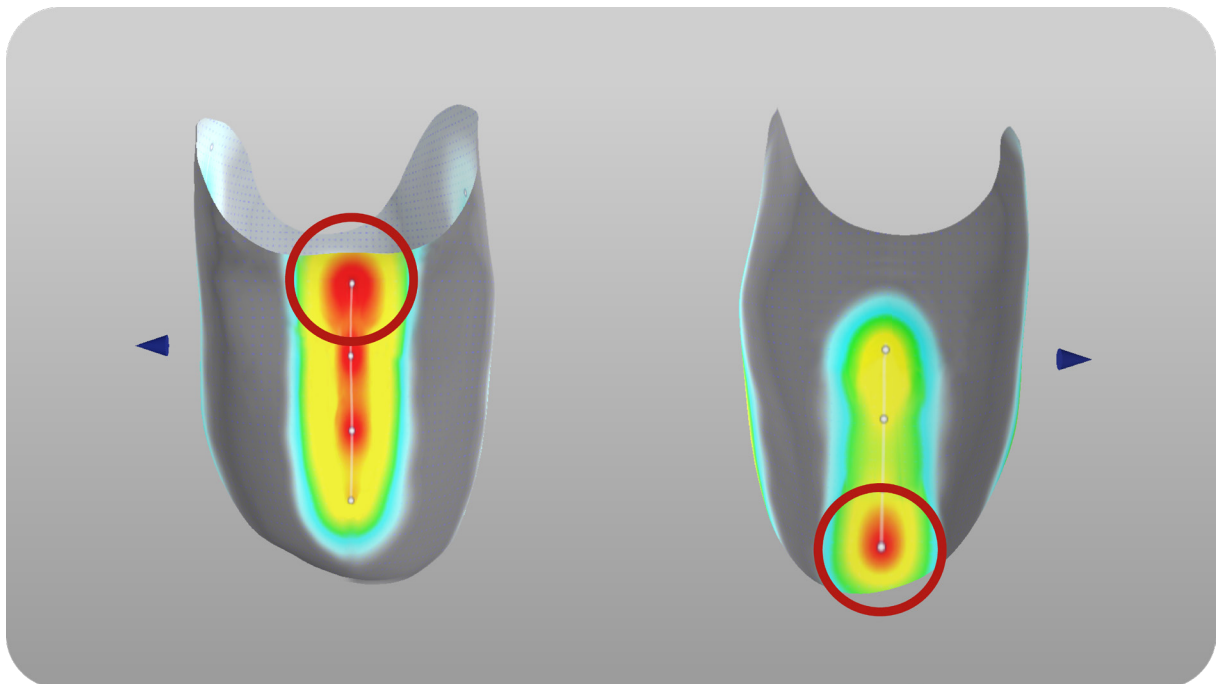
High pressures anterior-distal / posterior-proximal or mix of both  
**Visual from INSIGHT App**

Figure 15: Example of high pressures anterior-distal and posterior-proximal on a below-knee socket.

- Rapid and premature knee flexion
- Premature forefoot contact (slap foot)
- Longer prosthetic step

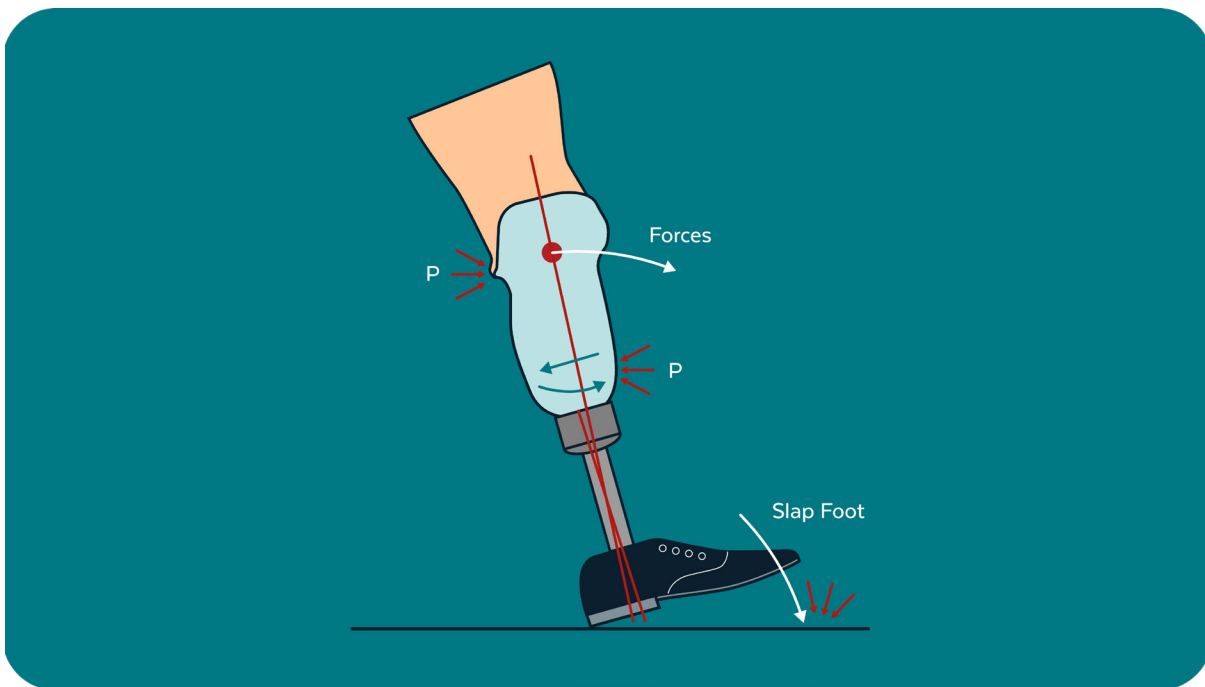
Figure 16: Example of gait deviation (lateral view) - high pressures present on anterior-distal / posterior-proximal.

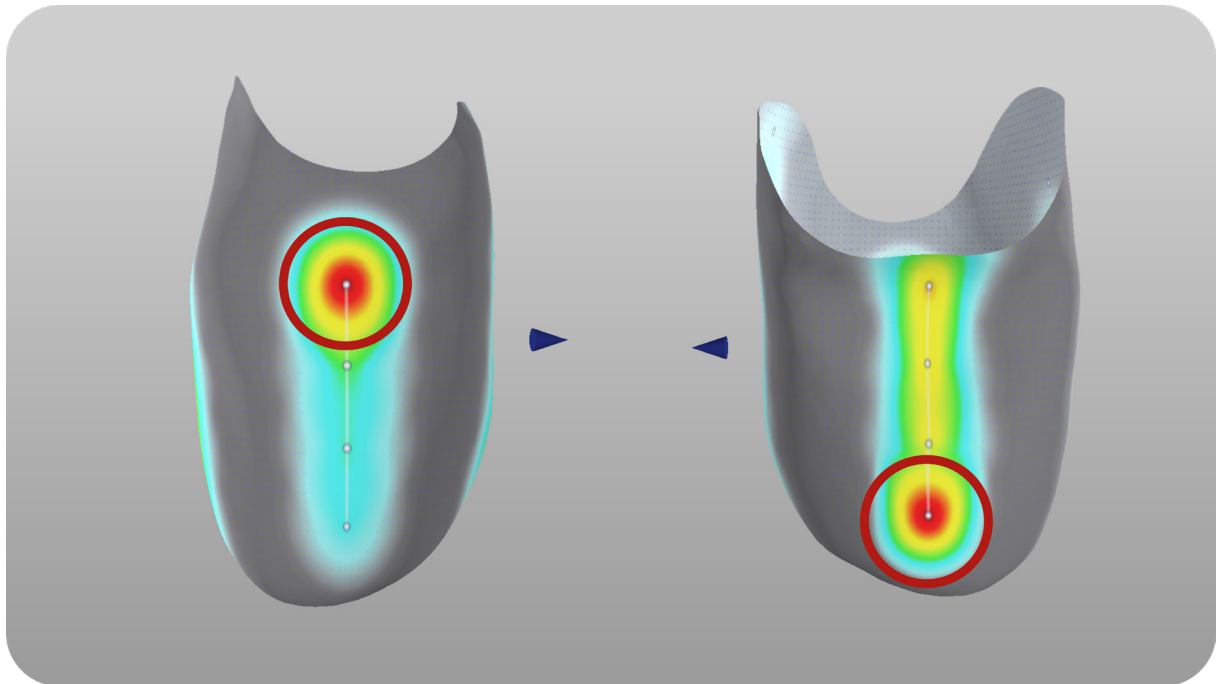
High pressures anterior-proximal at patella / posterior distal or mix of both

Figure 17: Example of high pressures anterior-proximal at patella and posterior-distal on a below-knee socket.

- Excessive or hyperextension of the knee while progressing into stance
- Patellar pain/discomfort
- Shorter prosthetic step

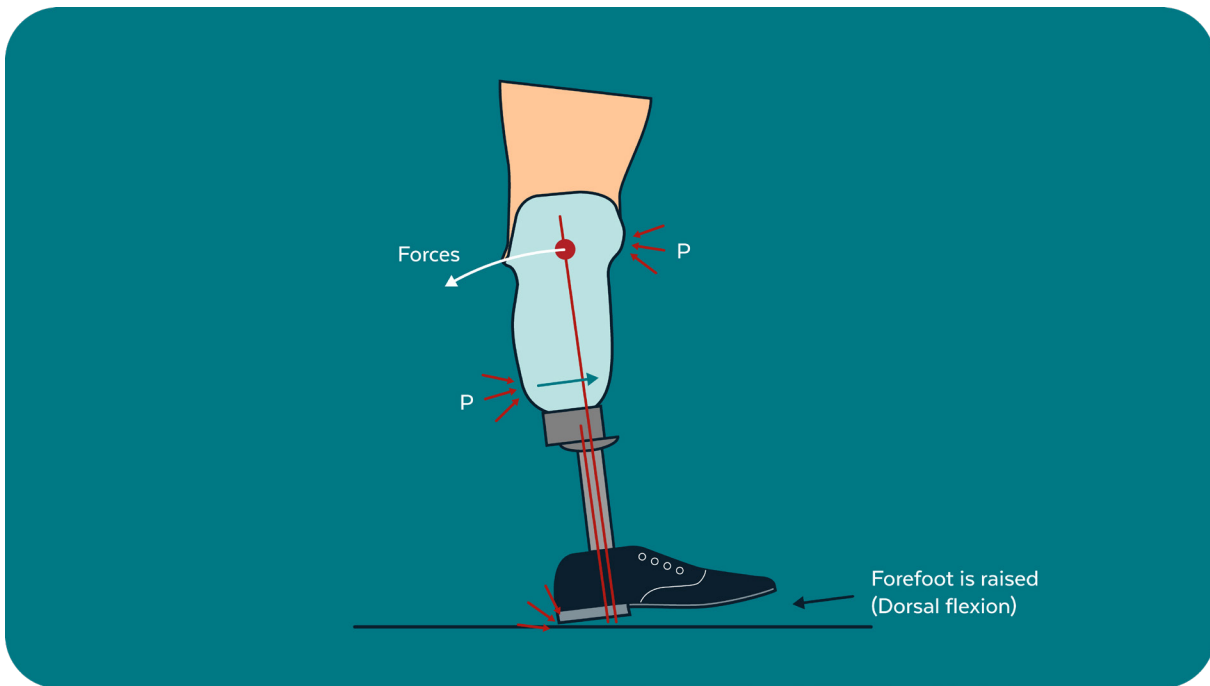
Figure 18: Example of gait deviation (lateral view) -High pressures anterior-proximal at patella / posterior distal or mix of both

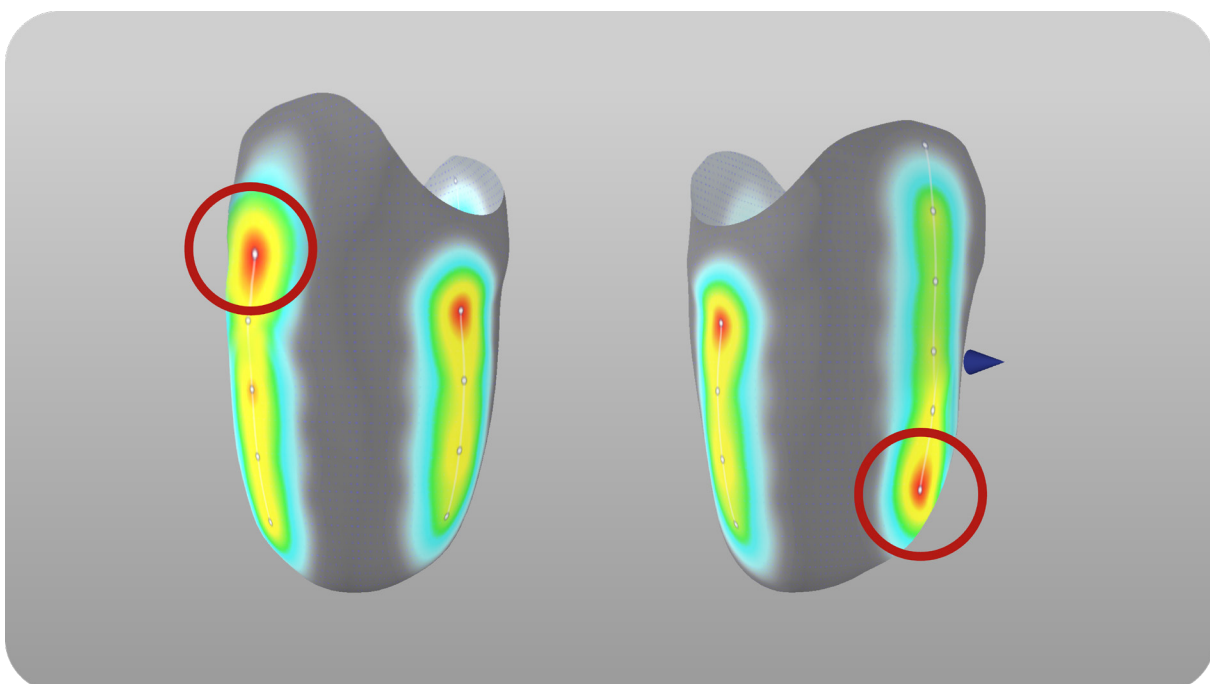
High pressures medial-proximal / distal-lateral or mix of both

Figure 19: Example of high pressures medial-proximal / lateral-distal on a below-knee socket.

- Lateral pylon lean
- Gap at lateral supracondylar area
- Discomfort or pain medial proximal/distal lateral
- Lateral trunk bend
- Narrow base of gait

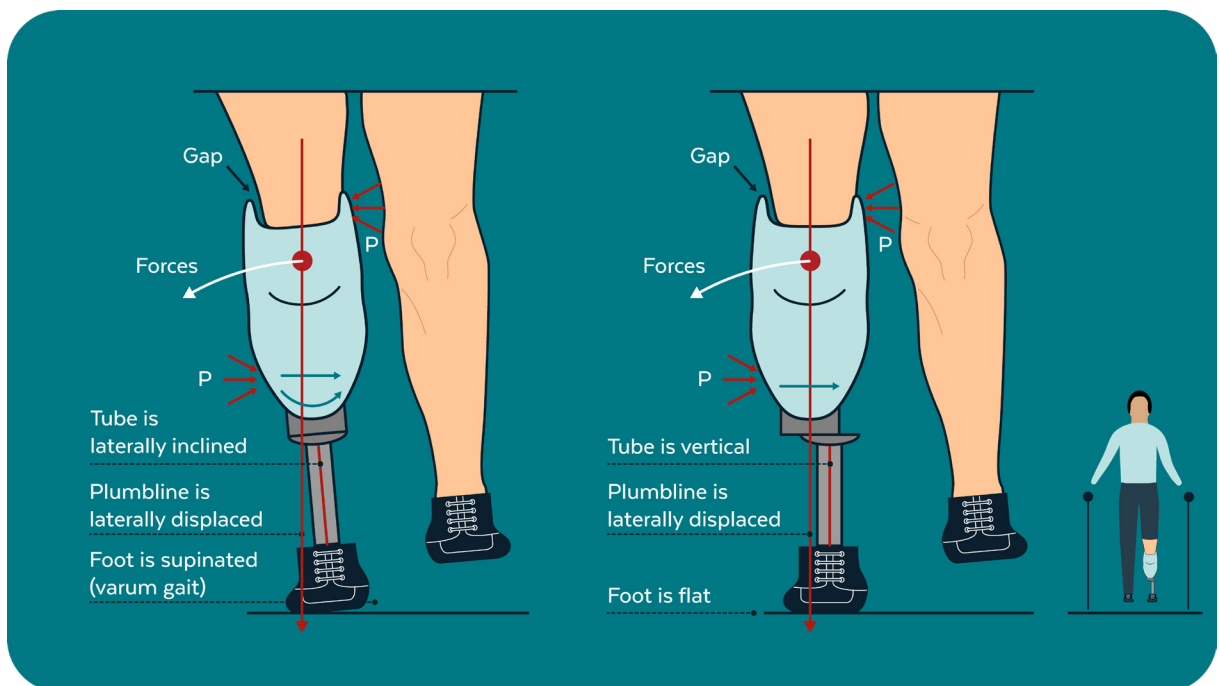
Figure 20: Example of gait deviation (anterior view) -High pressures medial-proximal / lateral-distal or mix of both.

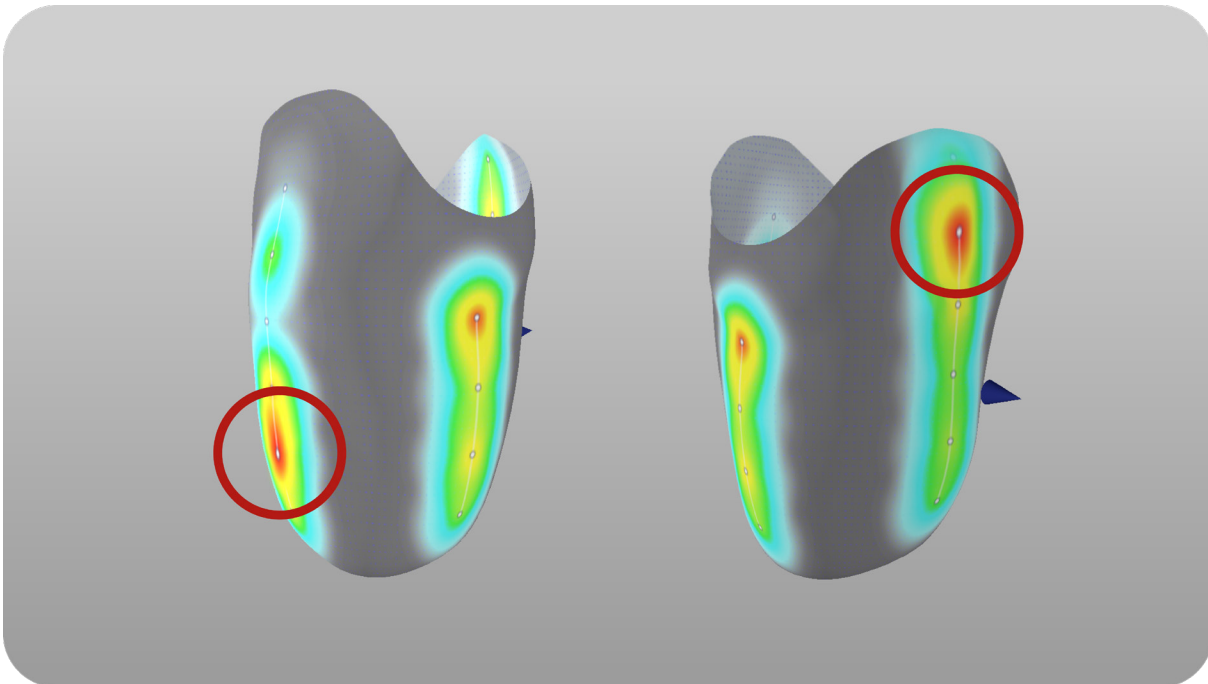
Figure 21: Example of high pressures medial-distal / lateral-proximal on a below-knee socket.

- Medial pylon lean
- Gap in the medial supracondylar area
- Excessive pressure at lateral proximal and medial distal areas.
- Wide base of gait

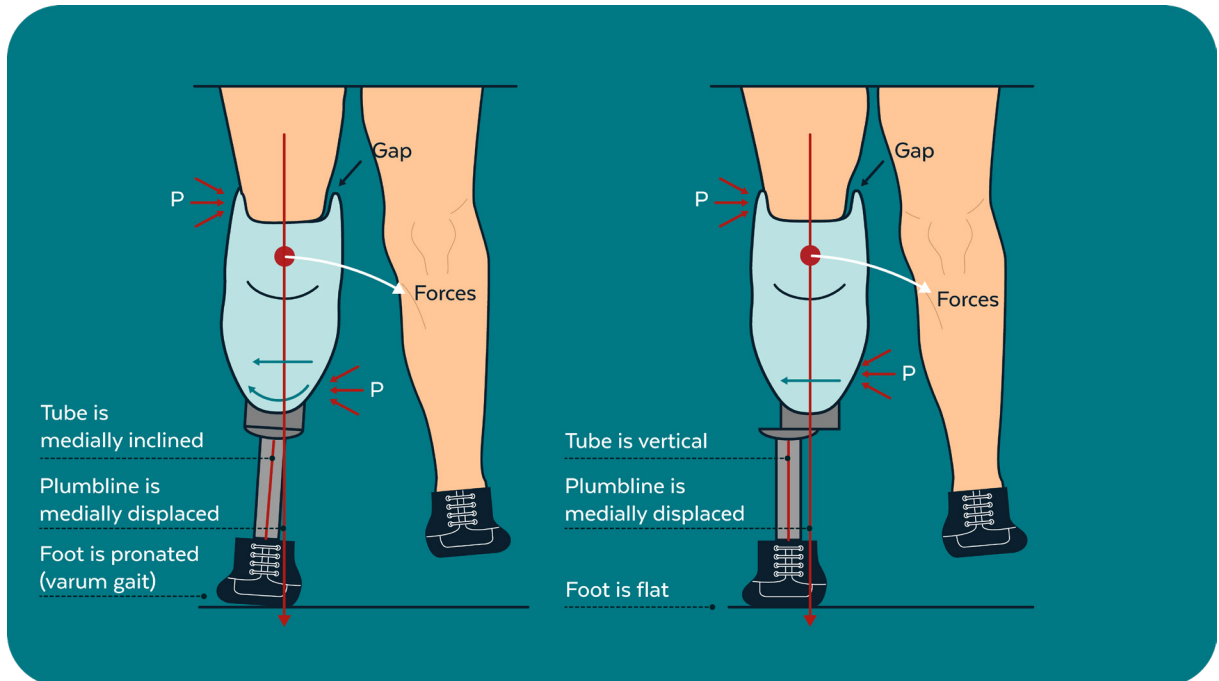
Figure 22: Example of gait deviation (anterior view) -High pressures medial-distal / lateral-distal or mix of both.

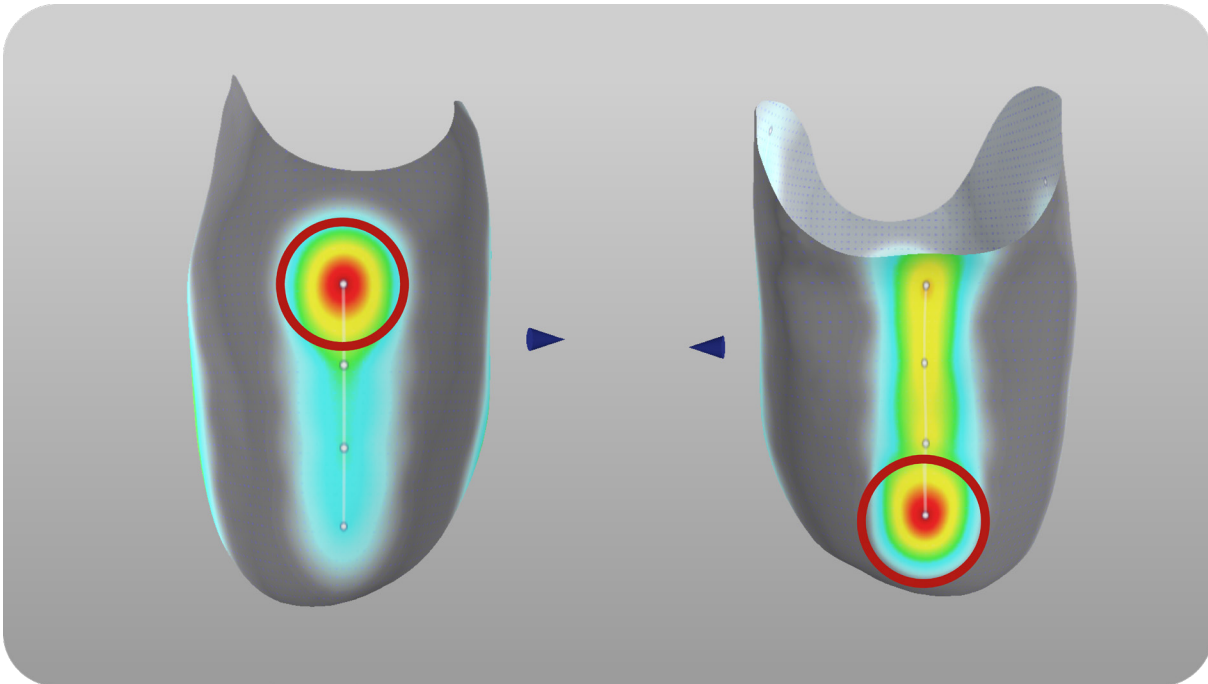
High pressures anterior-proximal / posterior-distal or mix of both  
Visuals from INSIGHT App

Figure 23: Example of high pressures anterior-proximal / posterior-distal on a below-knee socket.

- Hyperextension of the knee
- Patellar pain
- Sensation of walking uphill (difficulty clearing the toe)
- Delayed heel rise

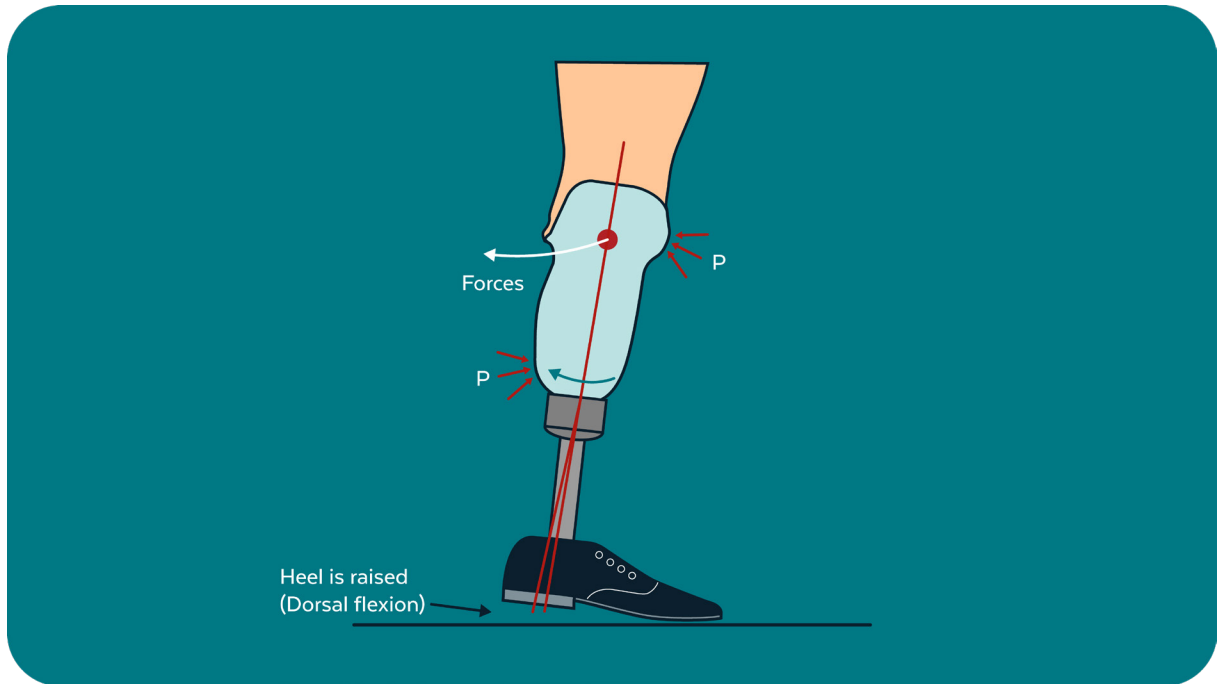
Figure 24: Example of gait deviation (lateral view) - High pressures anterior-proximal / posterior-lateral or mix of both.

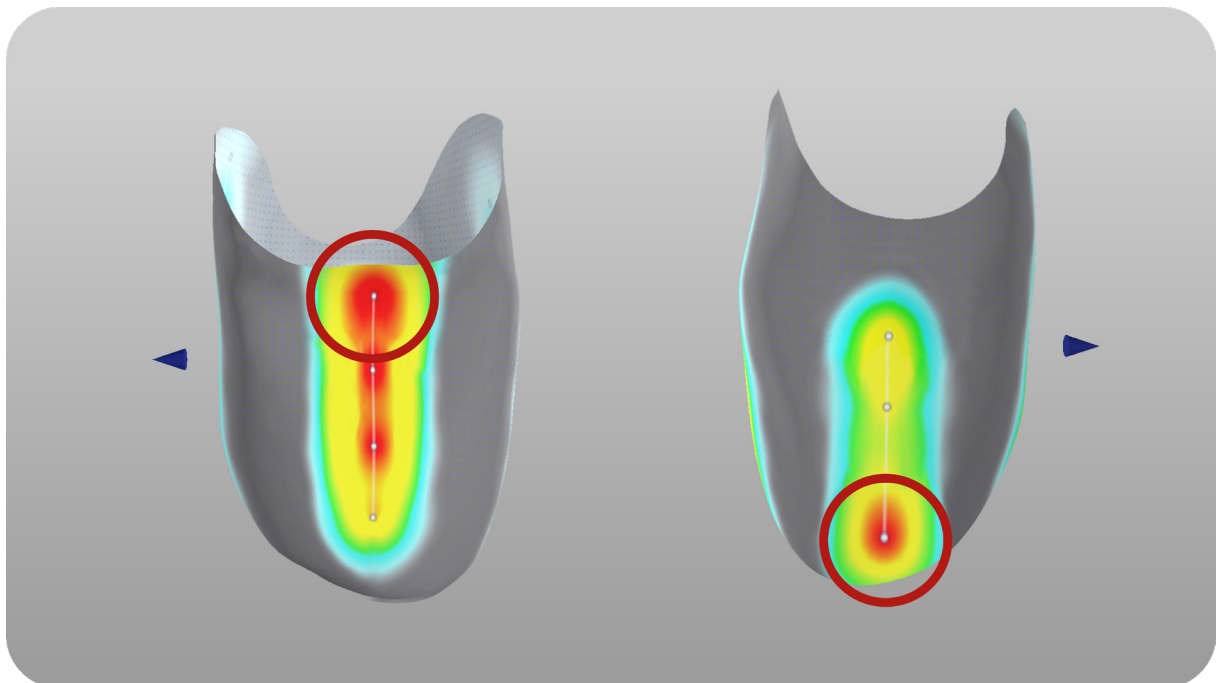
High pressures anterior-distal / posterior-proximal or mix of both.

Figure 25: Example of high pressures anterior-distal / posterior-proximal on a below-knee socket.

- Consistent knee flexion
- Early heel rise
- Drop off (sensation of walking downhill)

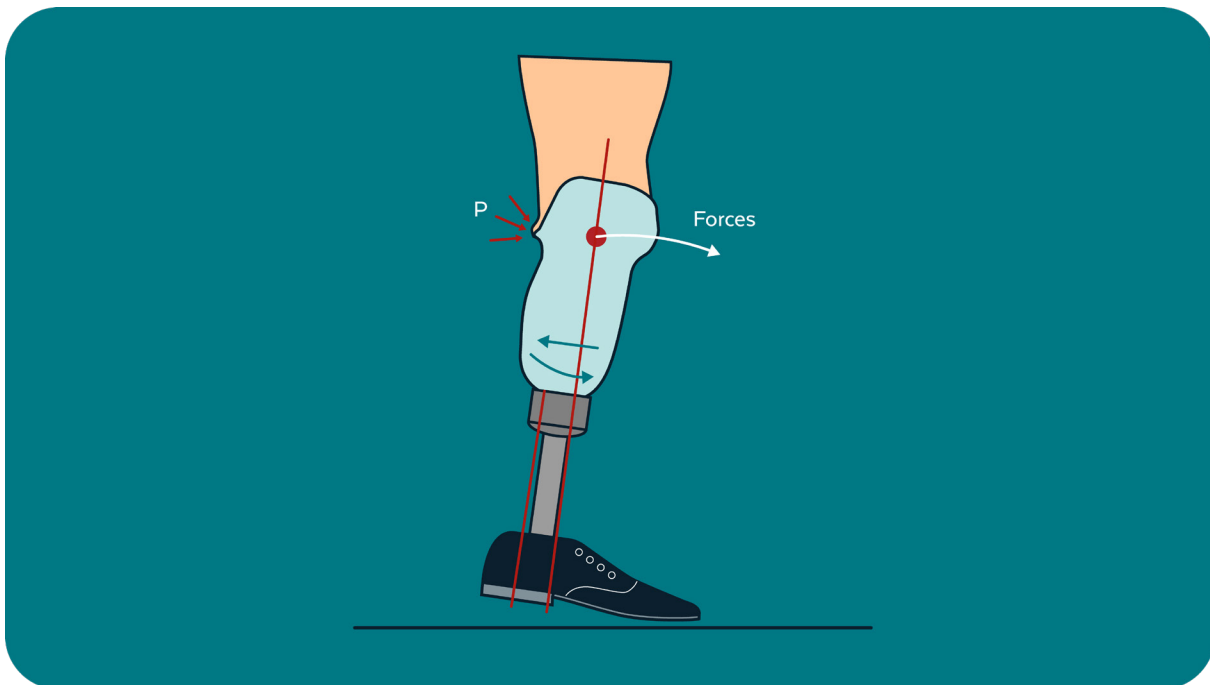
Figure 26: Example of gait deviation (lateral view) - High pressures posterior-proximal

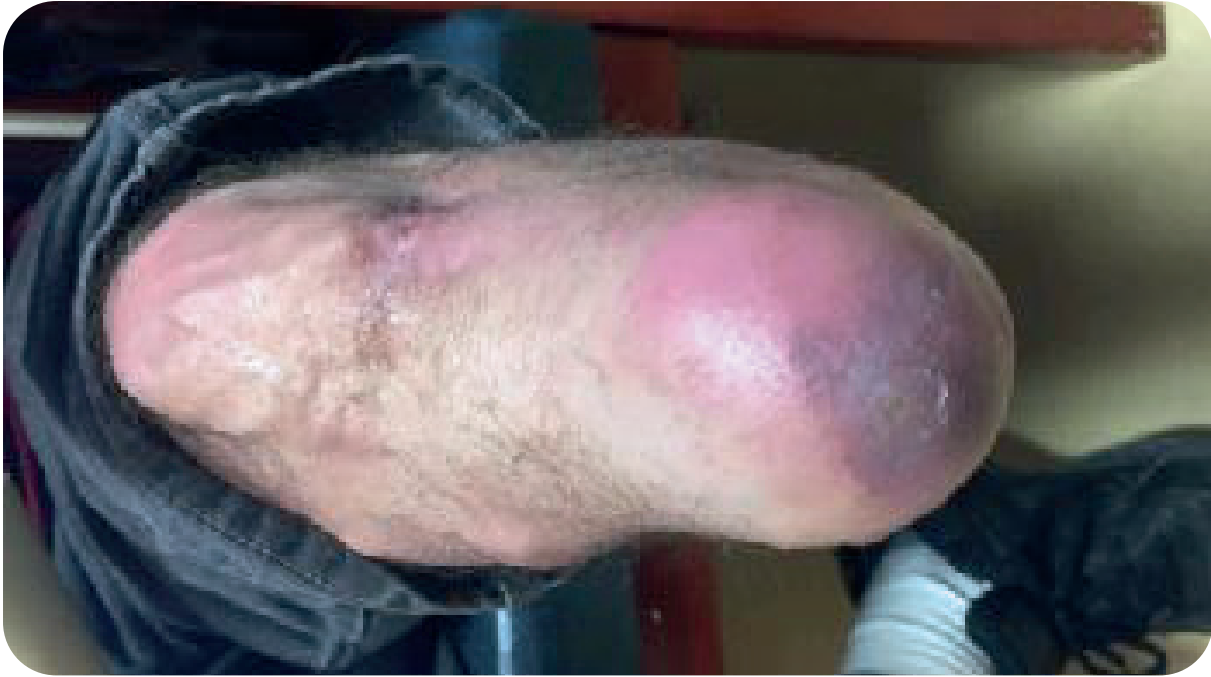
When Leslie removed his liner during his appointment, his limb was red and concerning. He was wearing a 3-ply sock fit and had only been wearing his prosthesis for 2 hours. His socket was scanned, and sensors were placed in areas of concern.

Figure 1: Leslie's residual limb.
