# INSIGHT Clinical Guide

How to understand and use  
INSIGHT System data

How to use INSIGHT System to  
improve clinical outcomes

Understanding the prosthetic  
socket fitting with INSIGHT  
System

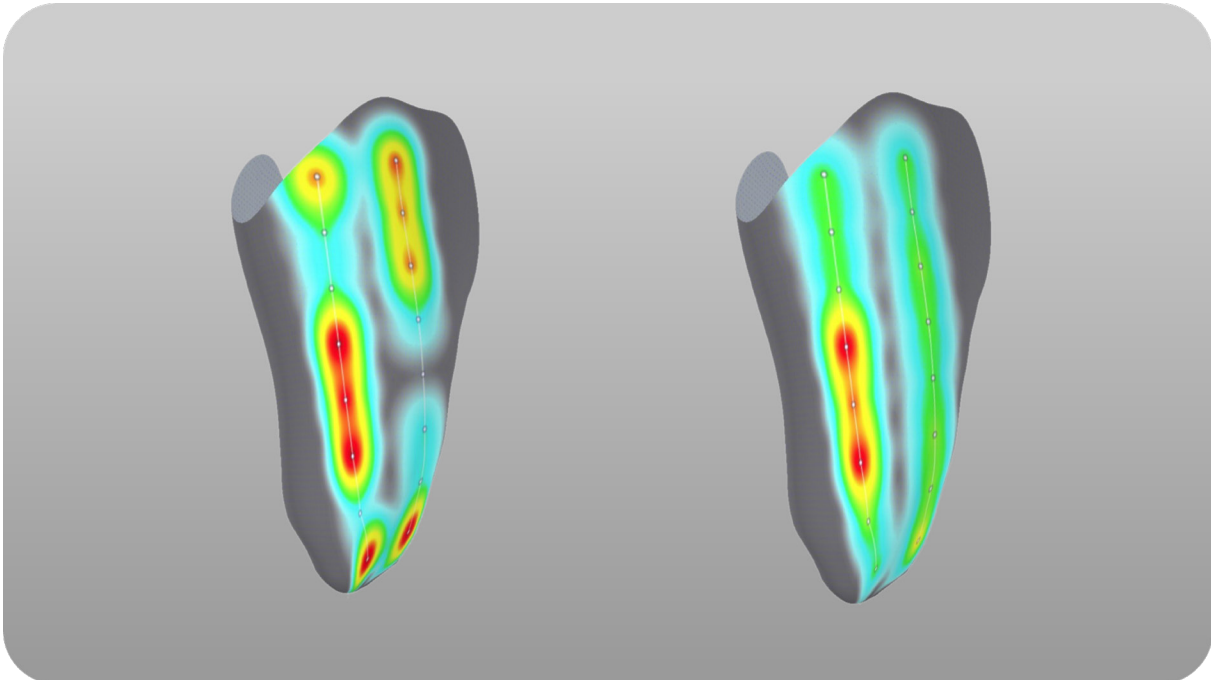
Figure 2: Leslie first dynamic acquisition with a 3-ply sock. Midstance (left) and Swing Phase (right).

He could clearly see pistoning within the socket when he did not have the proper socks on – higher pressure on the distal end. He could also see the lack of contact in the swing phase and high-pressure results for the bottom of his socket and limb during the stationary phase (Figure 2).

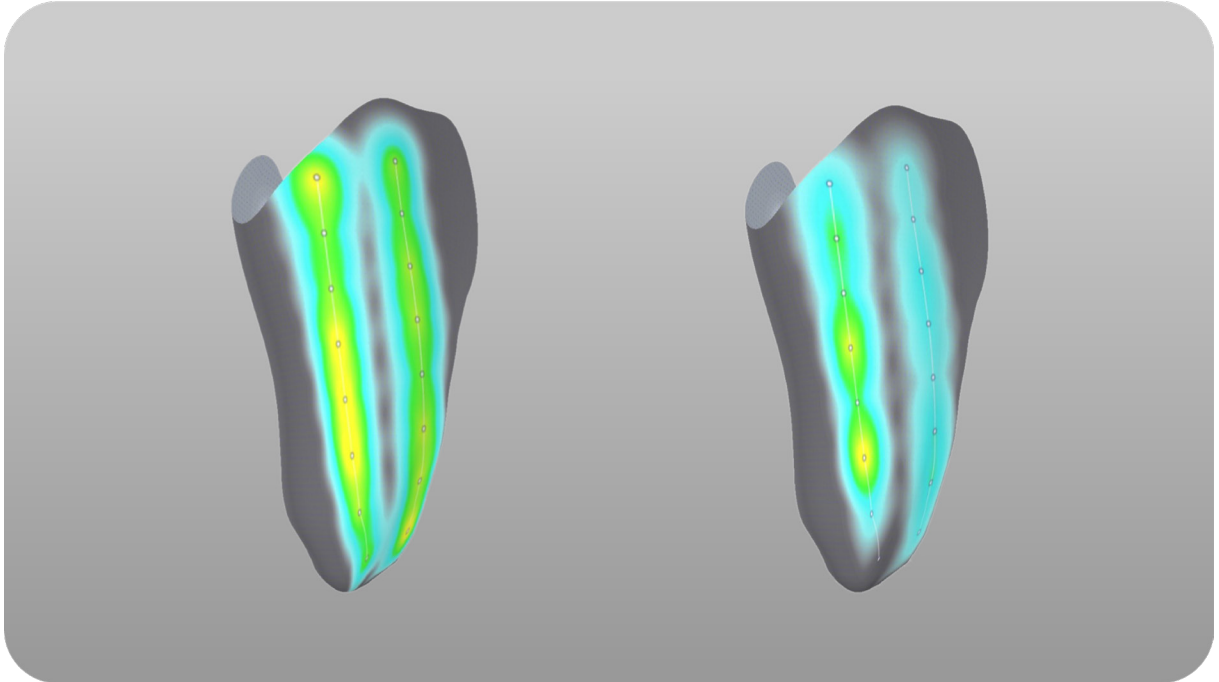
Figure 3: Leslie second dynamic acquisition with a 5-ply sock. Midstance (left) and Swing Phase (right).

When Leslie had the appropriate sock ply on, the plastic artery was located in the proper position and no longer caused unusual swelling or discomfort. He felt that he could walk for much longer (Figure 3). The loose fitting socket meant the plastic artery was receiving intermittent pressure, causing blood flow into the limb to be either completely free flowing, or if pressed upon blood flow stopped all together. This exchange from very high pressure on the artery to no pressure at all due to pistoning and movement within the socket meant Leslie had to take his socket off frequently throughout the day.

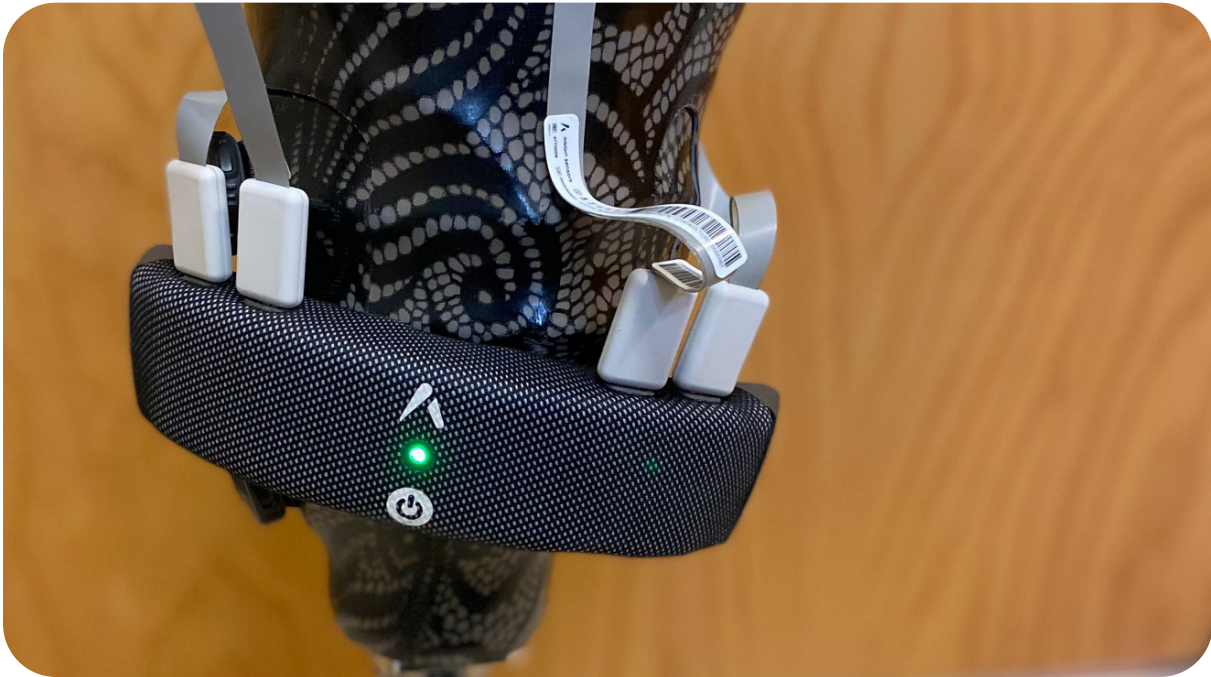
Figure 15: Kris's current prosthetic socket.

Kris’ previous prosthesis was made using traditional methods. It took 15 visits in total, including all follow-up appointments within two months after receiving the prosthesis.

Kris’ current prosthesis made using INSIGHT has reduced the total number of appointments to nine visits.

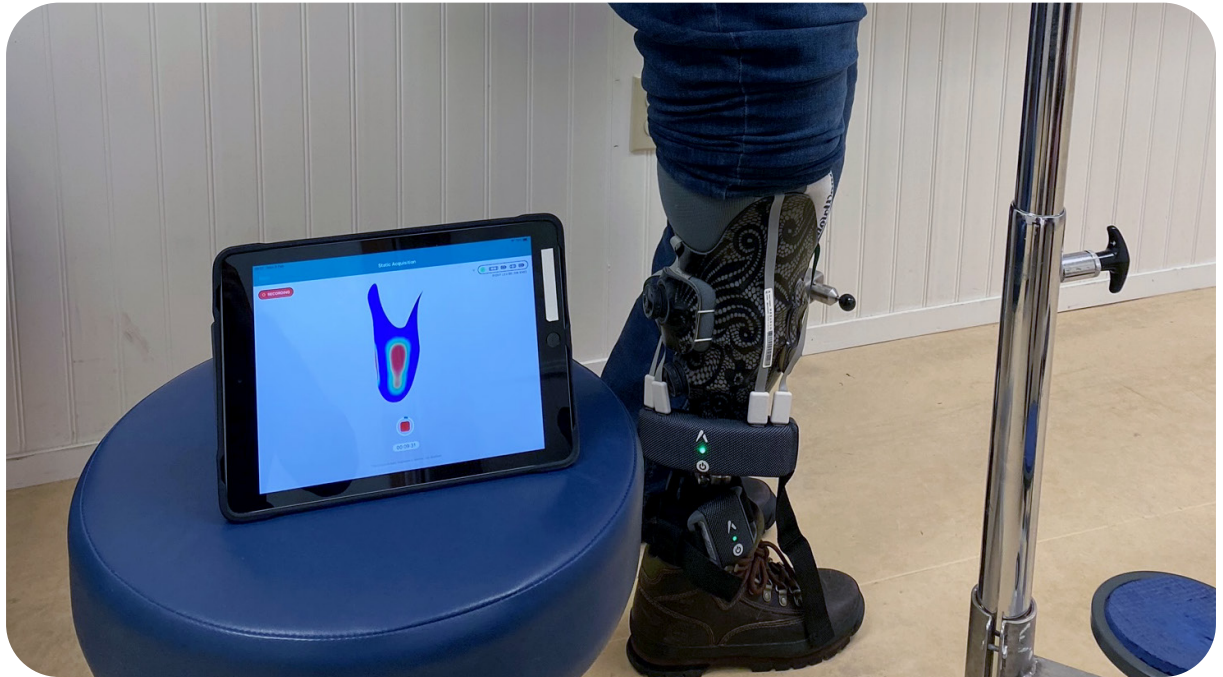
Figure 16: Static acquisition being performed using INSIGHT System.

The first pressure analysis demonstrated that the medial pretibial pad was located too far back on the socket and was therefore pushing too much onto the medial border of the tibia. The patient was unable to feel this due to excessive redundant tissue and lack of sensation.
